# Property Inspection Report

1234 Main Street, Dunwoody GA, 30338

Inspection Date: 9/26/14

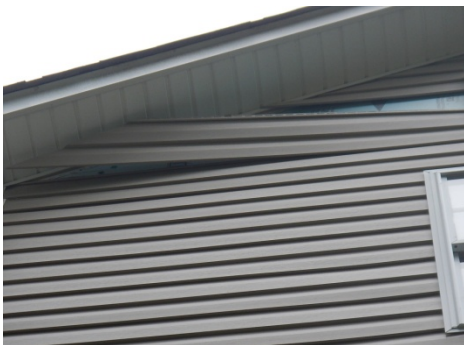
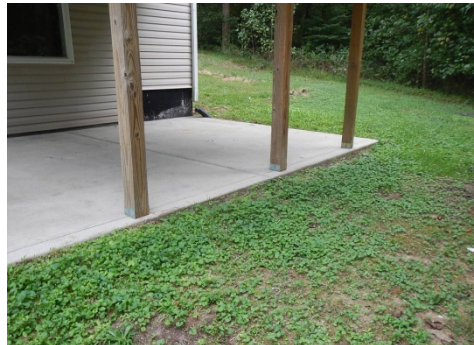
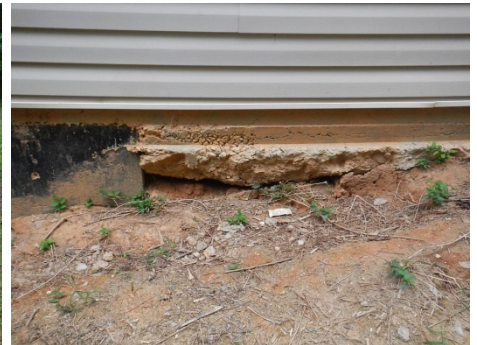
The lot drainage is good on the sides and back of the house, conducting surface water away from the building. The area at the front of the house is flat and should be monitored for water accumulation under the front porch.

The vinyl siding is in good condition. There is a needed repair at the top right side to prevent attic access to birds, insects, and rodents. Upper deck support beams are in direct contact with the lower patio concrete and the right side railing needs to be secured properly. Monitor bottom left side of house for future erosion. Subsurface drains are present but unable to determine where they outlet due to heavy foliage.

**Repair:** Hole and Vinyl siding at top right of house.

*Recommended Improvement: Stain / Seal exposed wood surfaces.*

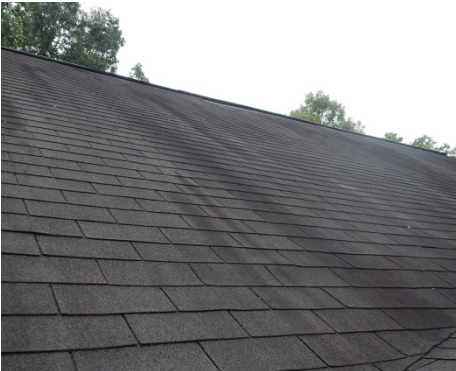
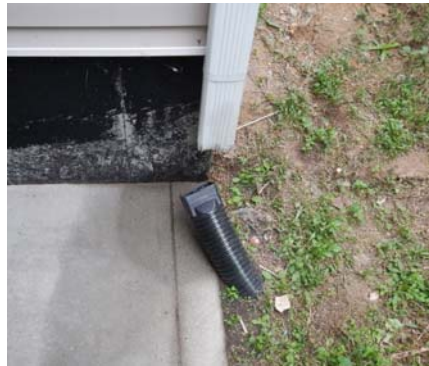
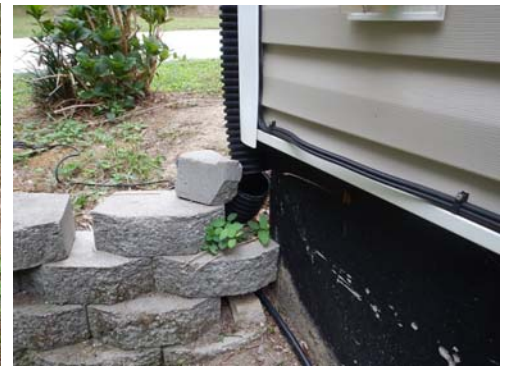
Some downspouts are not attached to underground drain piping causing water to accumulate close to the foundation.

**Repair:** Attach downspouts to drain piping and add components where needed to assure water drains away from the house.

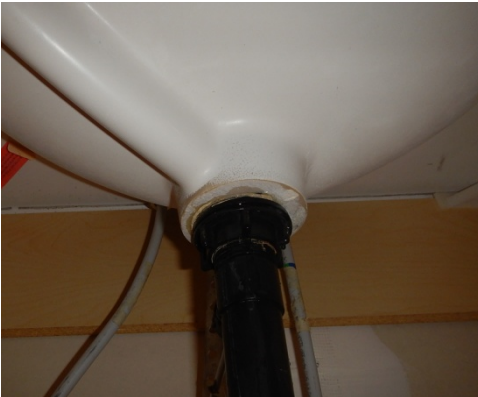
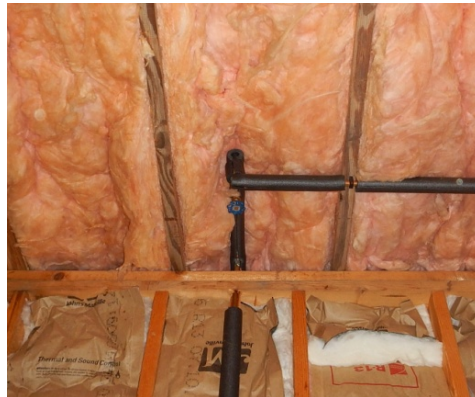
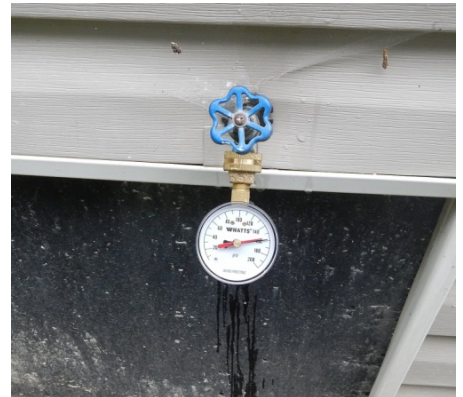
No under-cabinet or other leaks were observed however, the water has been shut off at the under-cabinet valves in the "attic" bathroom as a result of a leaking drain.

Several shut-off valves are located in the basement on the wall, ceiling, and above the water heaters. The bib at the front of the house has been disconnected, probably due to freezing. Another bib at the rear of the house is not functioning.

The water pressure is high at @150 psi when tested. Ideal residential pressure is between 60 - 80 psi. Symptoms of water pressure induced problems include leaks in multiple fixtures in the home, leaks that only appear intermittently - like at night, and toilets running occasionally without being used. In some cases, severe damage can occur to plumbing system devices.

**Repair:** Have a qualified plumber install a pressure regulator to reduce water pressure to 60-80 psi.

**Repair:** Leaking drain in "attic" bathroom.

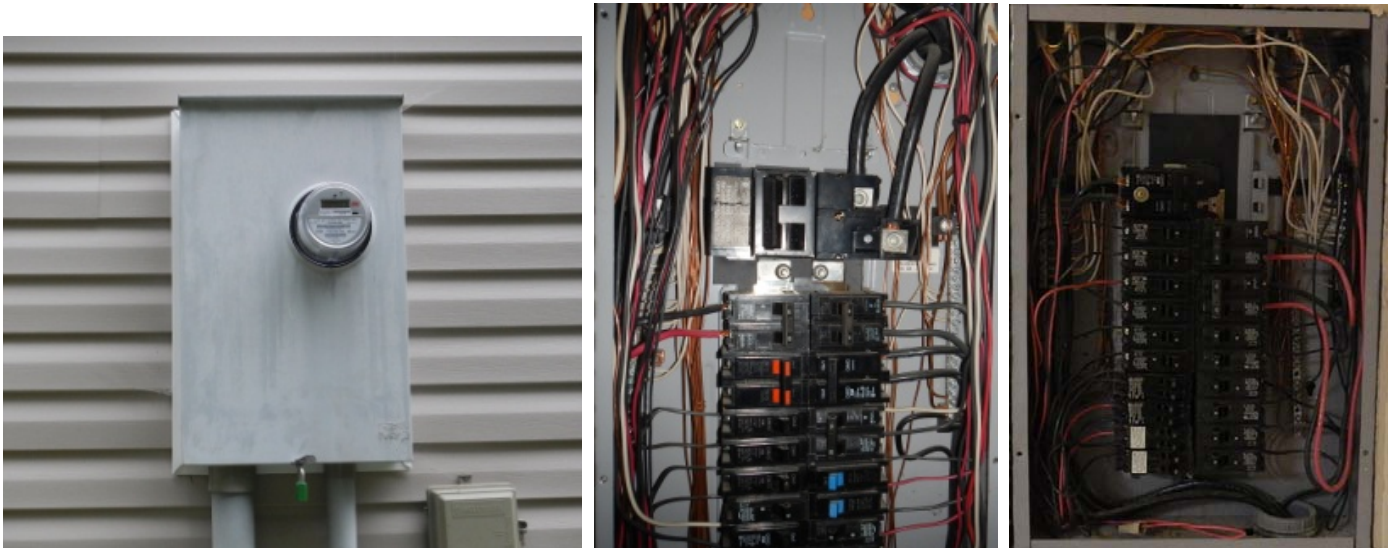
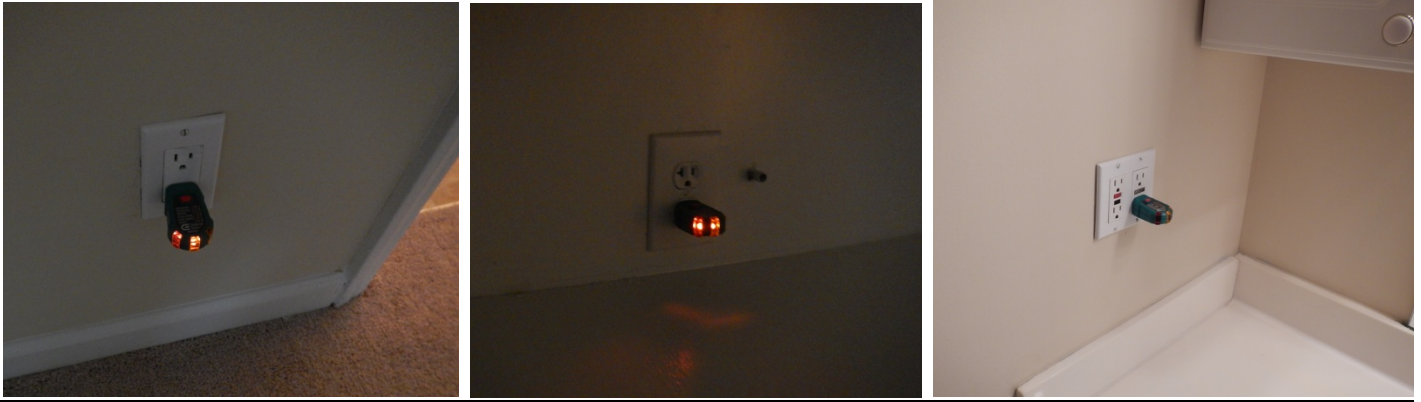
The electrical system is in good order. The electrical panel and sub panel are well arranged and all breakers are properly sized. All outlets and light fixtures that were tested operated satisfactorily except for several in the basement. The distribution of electricity within the home is good. All 3-prong outlets that were tested were appropriately grounded however two in the finished attic room are miswired. (The hot and neutral wires are reversed. This could damage sensitive electronics.

Some ground fault circuit interrupter (GFCI) devices failed when tested. These devices are extremely valuable, as they offer an extra level of shock protection. Dedicated 240 volt circuits have been provided for all 240 volt appliances within the home. All visible wiring within the home is copper. This is a good quality conductor.

Some wall switches and receptacles are loose and are not functional.

Several smoke detectors were beeping and some did not respond when tested at the time of inspection.

**Repair:** Replace Ground Fault Circuit Interrupters in the following locations:

**Repair:** Miswired receptacles in finished attic area:

**Repair:** Change batteries in ALL smoke detectors.

**Recommended Improvement:** Re-align / tighten loose wall switches and receptacles.

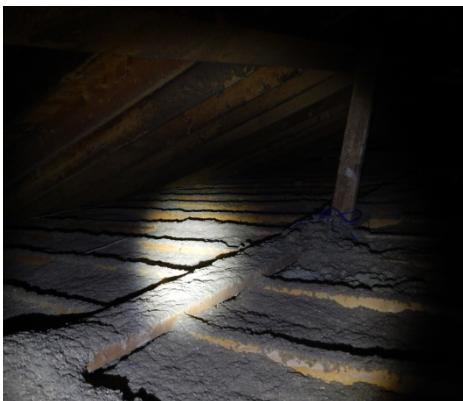
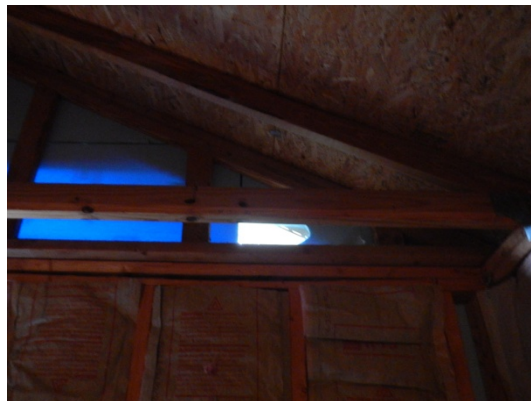
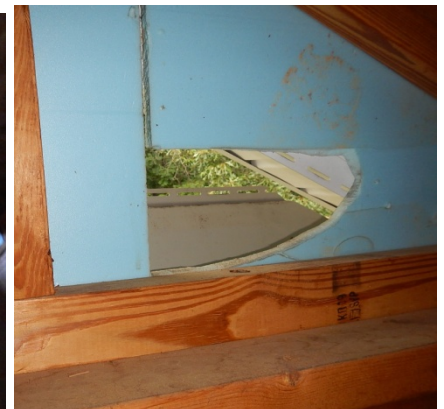
There is a hole in the weather barrier at the top right, far side of the attic. It is where the vinyl siding is pulling away from the house. This needs to be addressed ASAP to prevent birds, rodents, and insects from gaining access to the attic. There is no evidence of these pests at this time.

**Repair:** Replace missing weather barrier, fix siding, and insulate.

**MONITOR:** Periodically check attic for moisture and pests.

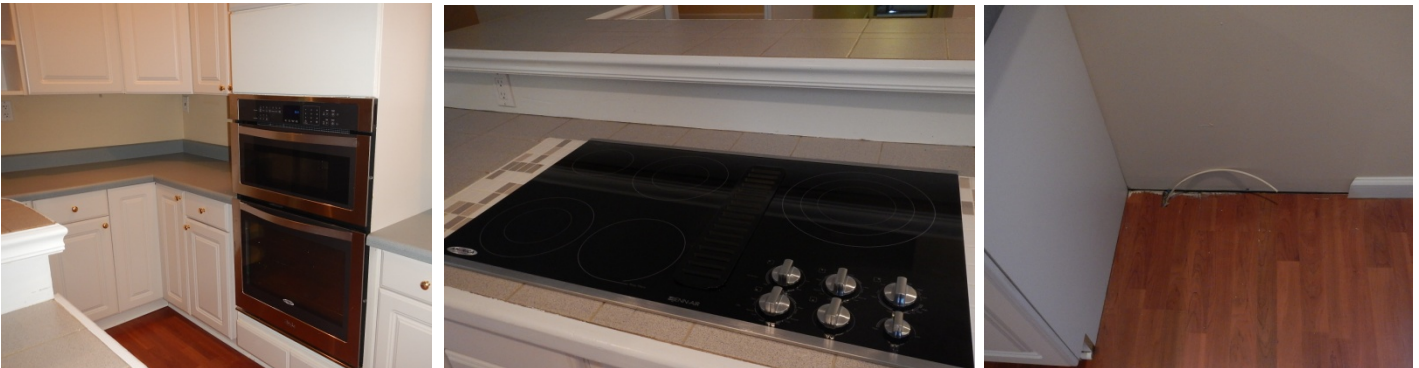
The laminate floor is sound and free of damage and a water line is available for a refrigerator. The laminate and tile countertops are stain and scratch free. The cabinets are in good condition however some cabinet doors require hardware.

**REPAIR:** Missing cabinet hardware.

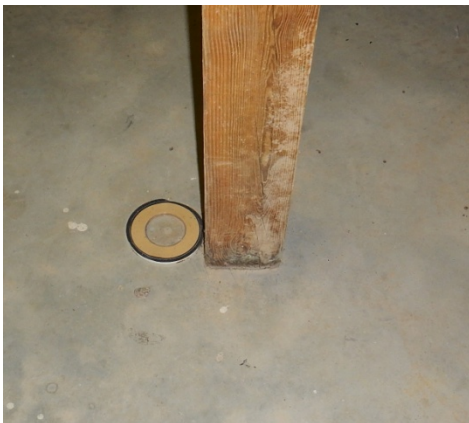
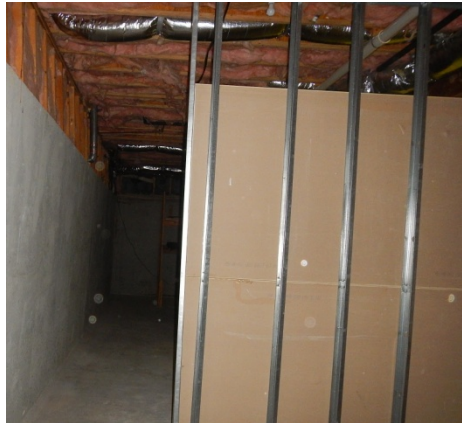
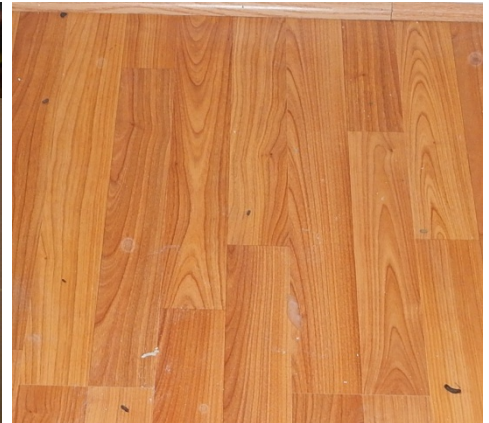
The basement is in good condition. There is no sign of moisture except for water stains around the bottom of the 4 x 4 support beams. The concrete foundation is level with no cracks. The wood floor structure is well built. Although no pests were observed, there were some rodent droppings in the finished room containing the electrical sub-panel. Many receptacles are non functional near the Heating, A/C room and finished room.

**Repair:** Affix stair railing to wall.

**Repair:** Trace electric lines to non-functioning receptacles.

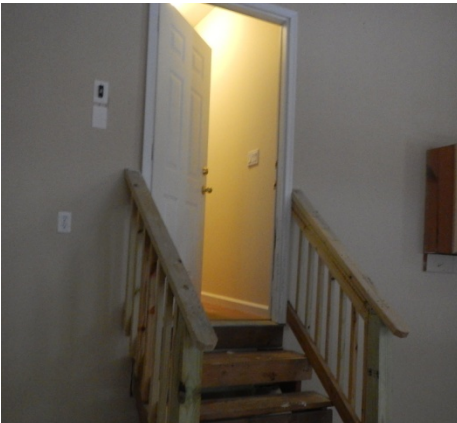
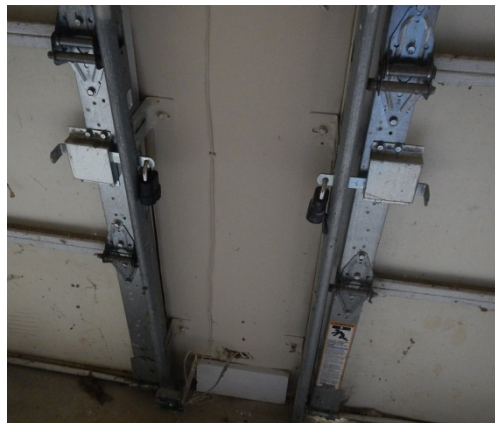
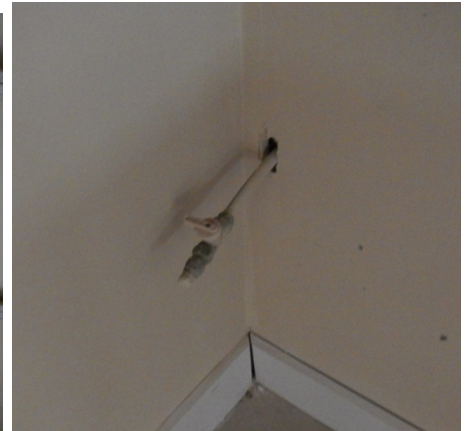
The garage is below the main floor grade and is in good condition. The floor is clean and free of debris. The doors and obstacle reverse system could not be tested due to being padlocked. The auto reverse mechanism on the overhead garage door should be tested by the owner to assure it responds properly as a door that doesn't reverse can injure someone or fall from the ceiling. There is a sealed off gas line and wire-capped electrical lines entering the garage through the walls.

**MONITOR:** Owner must check door and obstacle reverse functionality.

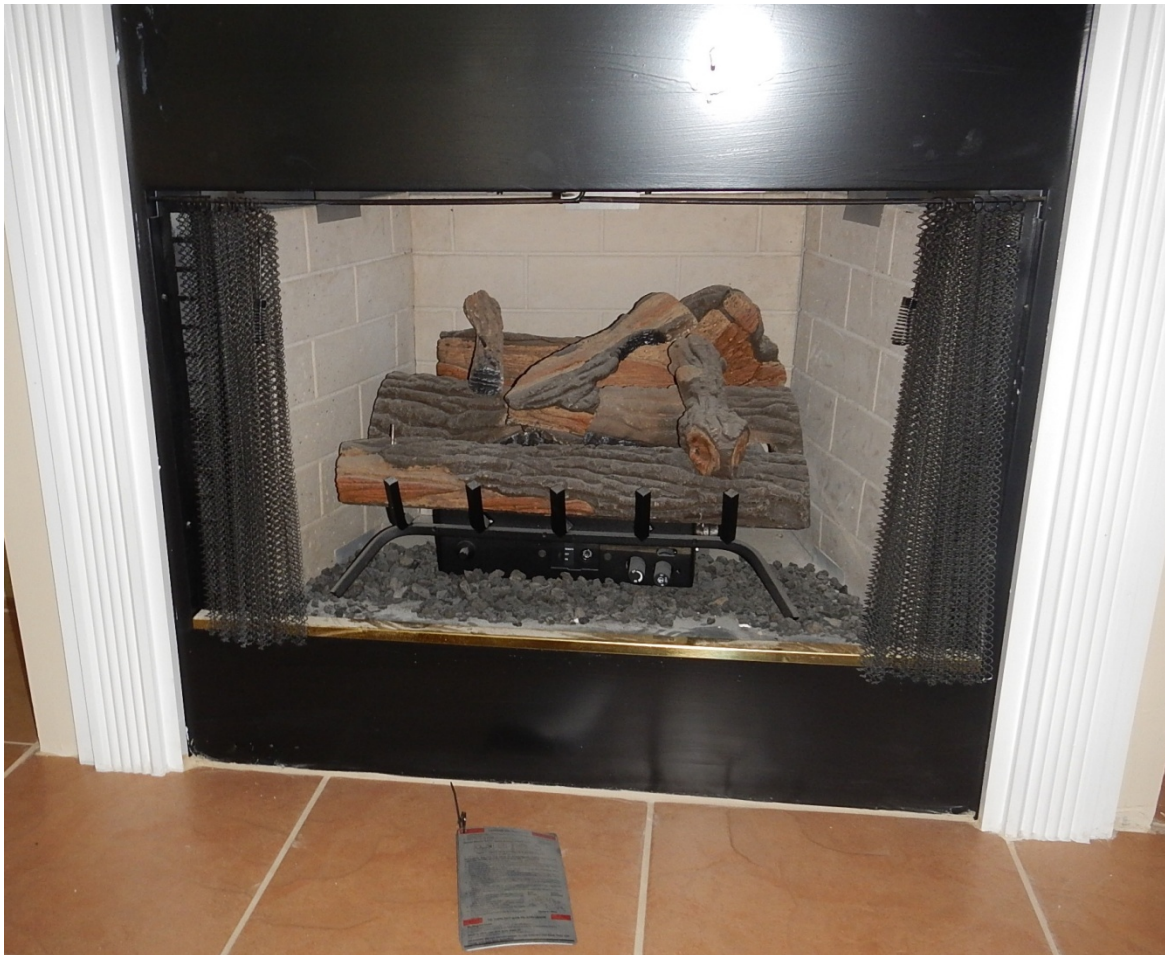
A gas fireplace and artificial logs have been installed but there is no gas service to the house. The fireplace and its components are in good condition but are not functional at this time.
