# Property Inspection Report

1234 Main Street, Dunwoody GA, 30338

Inspection Date: 9/26/14

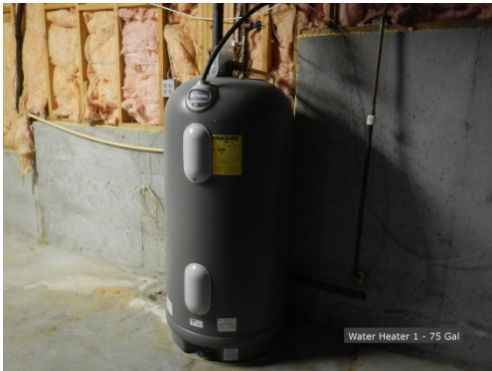
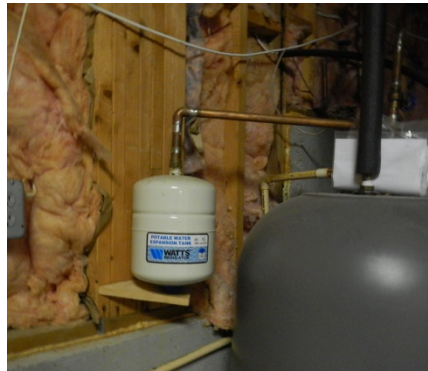
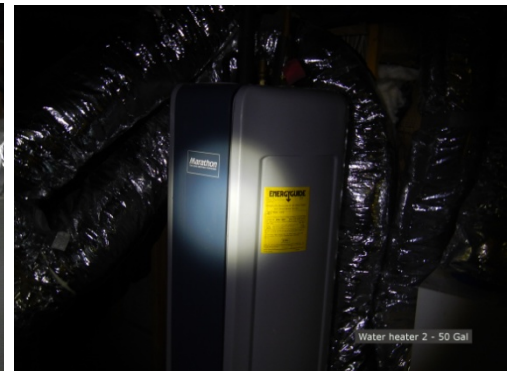
Location: Heating, A/C Room

Expansion tank: No

**Repair:** Have a qualified plumber install a pressure regulator to reduce water pressure to 60-80 psi.

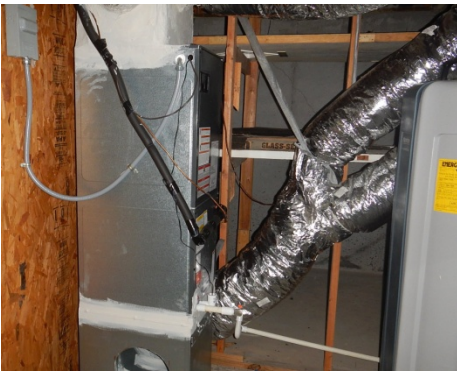
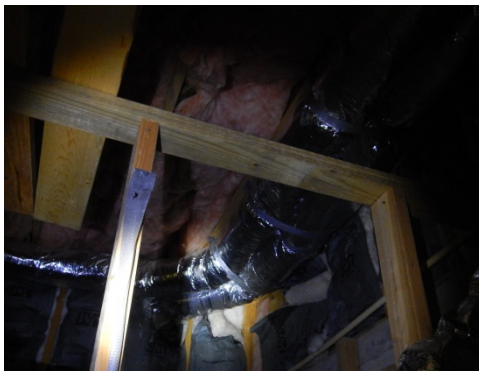
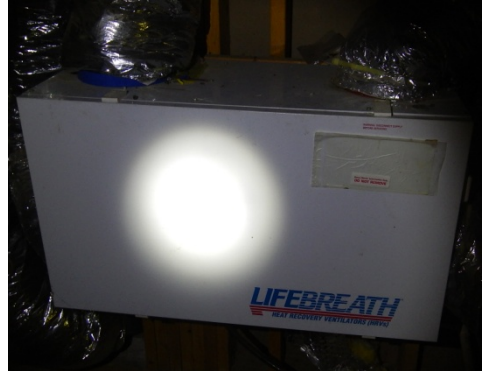
The heating system is in good condition. The electric furnaces are @1 year old with a low probability of failure within the next ten years. The system responded properly to operating controls and heated all levels of the home except attic area. Ductwork is satisfactory and no rust was observed. Attached are Lifebreath HRVs and air filters. These increase heat efficiency and air quality to the house. Lifebreath air filters were not inspected.

**MONITOR:** Clean / replace filters when needed.

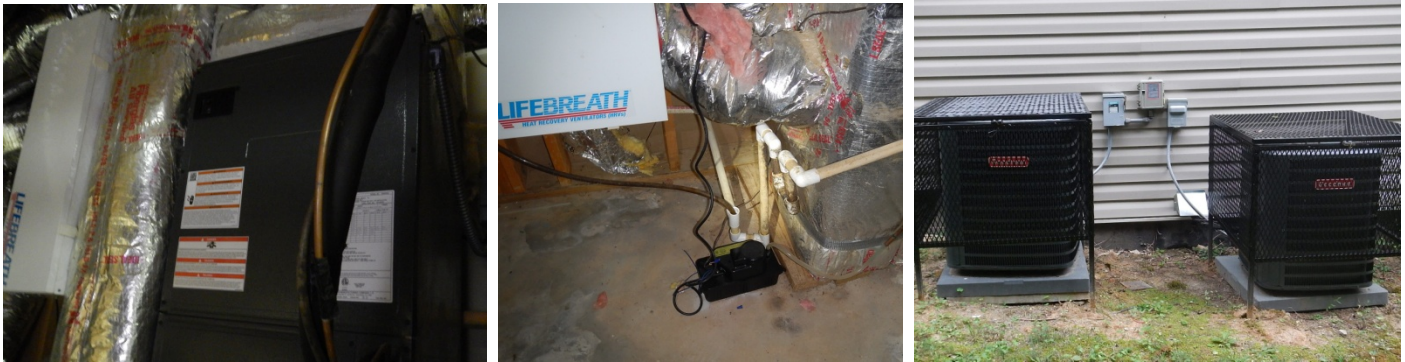
The capacity and configuration of the system is sufficient for the home with a low probability of failure within 10 years. The system responded properly to operating controls and cooled the home except the "attic" area which has a window A/C unit. The system shows no visible evidence defects and the outdoor units functioned as intended. The electrical disconnects are located above the outdoor compressor units.

**RECOMMENDATIONS:** There are no Air Conditioning areas requiring attention at the time of inspection.

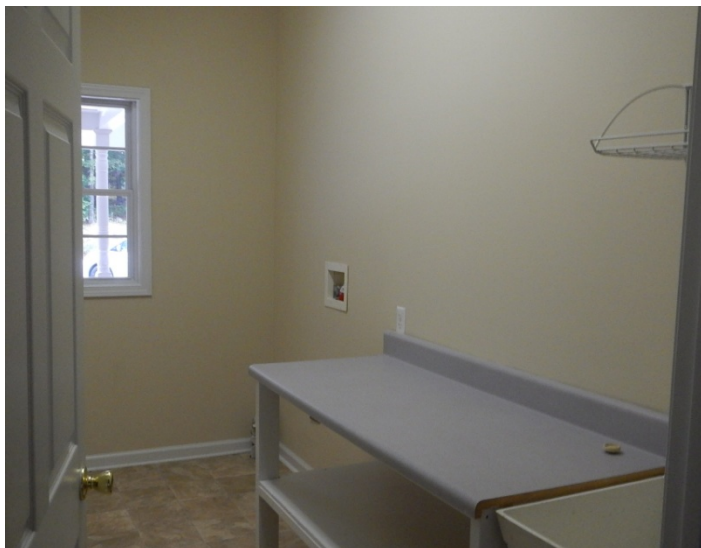
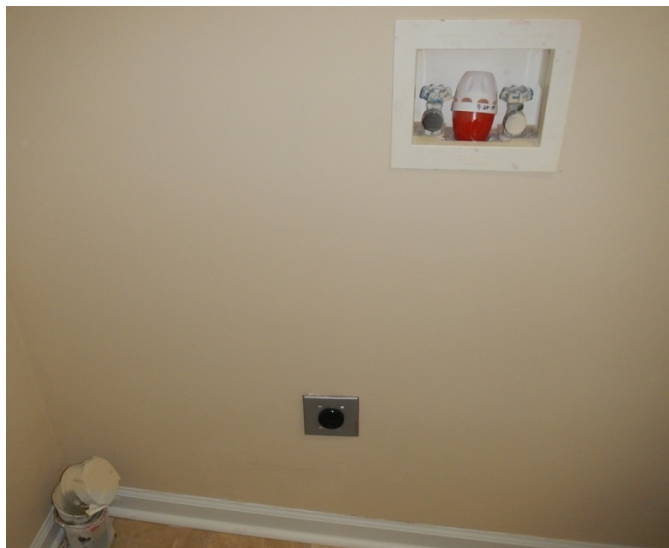
The laundry area is in good condition. Cabinet hardware is functional. The sink is operational and the room is well vented.

MONITOR: Periodically clean the dryer vent.
